Smitten Home Inspection  
8782 Hastings Circle NE  
Blaine, MN 55047

# Smitten Home Inspection

Mr. & Mrs. Client  
1234 Anywhere Street  
Page 1 of 23

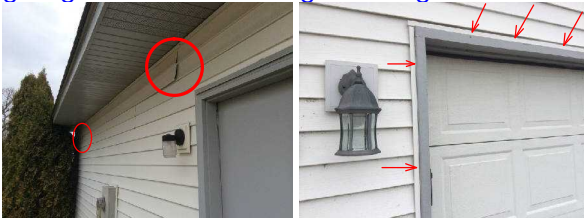
1. Type of Structure: Attached Car Spaces: 3  
2. ☒ ☐ ☐ ☐ ☐ Garage Doors: Insulated aluminum  
3. ☒ ☐ ☐ ☐ ☐ Door Operation: Mechanized  
4. ☒ ☐ ☐ ☐ ☐ Door Opener: Sears, Genie  
5. ☐ ☐ ☐ ☒ ☐ Exterior Surface: Vinyl siding - Loose pieces. Need localized repair. Missing drip caps over garage trim and missing caulking between trim and j-channel

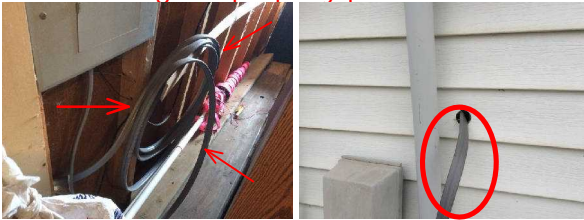
1. Service Size Amps: 200 Volts: 110-240 VAC
2. ☒☐☐☐☐ Service: Copper
3. ☒☐☐☐☐ 120 VAC Branch Circuits: Copper
4. ☒☐☐☐☐ 240 VAC Branch Circuits: Copper and aluminum
5. ☒☐☐☐☐ Aluminum Wiring: specific appliances only
6. ☐☐☐☐☒ Conductor Type: Romex - **Excess hot tub wiring not properly secured by main panel. Outdoor romex wiring not properly protected. Evaluation by a licensed electrician is recommended**

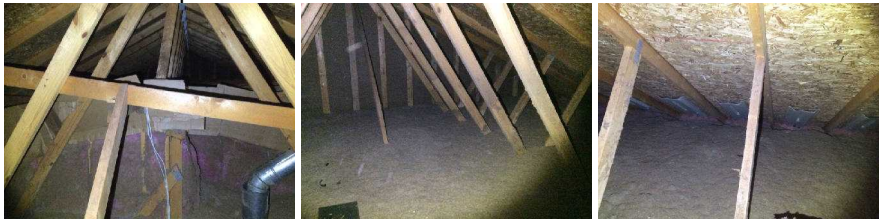
1. Method of Inspection: From the attic access
2. ☒ ☐ ☐ ☐ ☐ Unable to Inspect: 40%

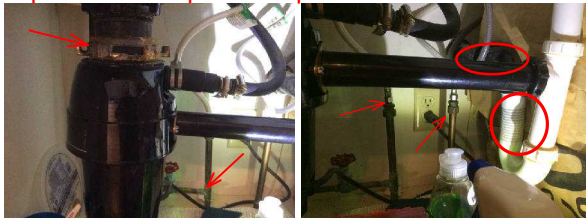
1. ☒ ☐ ☐ ☐ ☐ Cooking Appliances: Frigidaire
2. ☒ ☐ ☐ ☐ ☐ Ventilator: Sharp
3. ☒ ☐ ☐ ☐ ☐ Disposal: General Electric
4. ☒ ☐ ☐ ☐ ☐ Dishwasher: Kitchenaid
5. Air Gap Present? ☒ Yes ☐ No
6. ☒ ☐ ☐ ☐ ☐ Refrigerator: Kenmore
7. ☒ ☐ ☐ ☐ ☐ Microwave: Sharp
8. ☒ ☐ ☐ ☐ ☐ Sink: Stainless Steel
9. ☒ ☐ ☐ ☐ ☐ Electrical: 110 VAC GFCI
10. ☐ ☐ ☐ ☐ ☒ Plumbing/Fixtures: PVC, ABS, Stainless steel - The faucet is leaking at base. The sink drain trap is corroded. This area should be monitored for leakage and repairs made as needed. The supply piping under the sink is corroded. It may be desirable to replace it before leaks develop. Missing shut off valves under sink, recommend installation sooner than later. Pitch on ABS drain plumbing improper, correct soon. Flexible p-trap is non-standard plumbing and should be replaced. A qualified plumber should be consulted for repairs immediately.

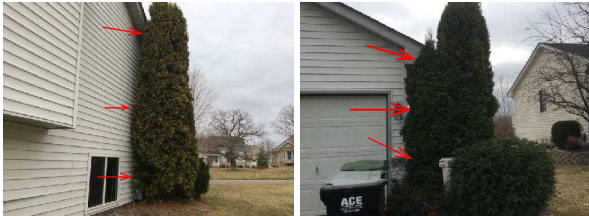
3. Vegetation: Shrubs - Shrubs planted too close to structure, removal may be required. Can affect siding materials.

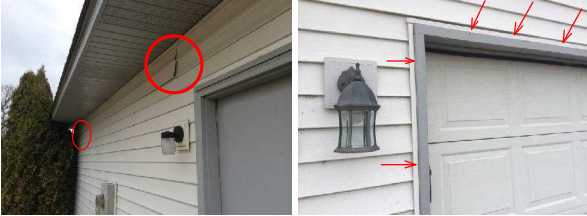
7. Attached Garage Exterior Surface: Vinyl siding - Loose pieces. Need localized repair. Missing drip caps over garage trim and missing caulking between trim and j-channel

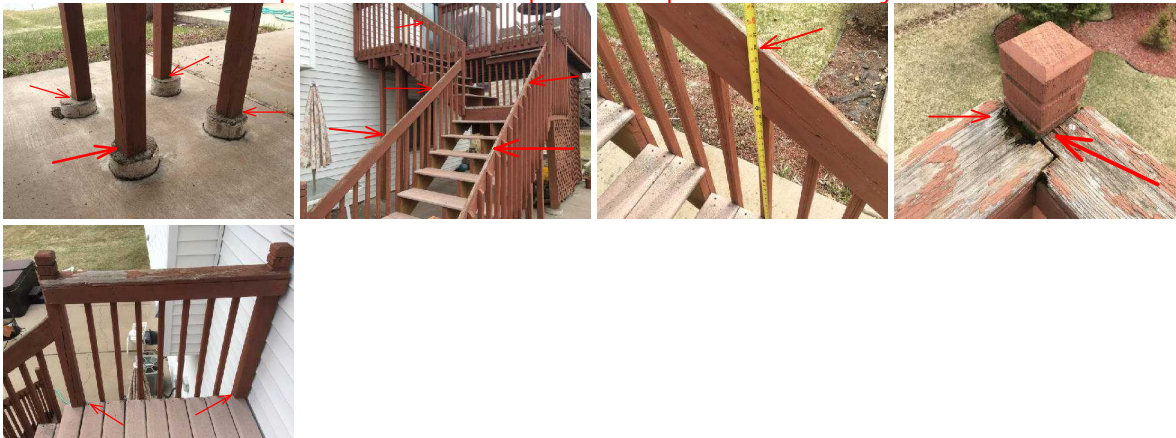
5. ☐☐☐☐☒ Deck: Treated wood - Deck support post rest directly on concrete footings. This makes the posts prone to premature rot at the base. Recommend adding metal post bases. Railing on stairs not built to building standards (undersized). Recommend adding proper designated handrail for proper safety. Handrail on stairs built below minimum height standards for safety. Should be between 34"-38" at stair tread nosing. Currently only 30" high. Overall wood condition of railing is poor and is potentially safety hazard due to rot. Railings are noticeably loose. Recommend qualified contractor perform repairs immediately.

1. Deck: Treated wood - Deck support post rest directly on concrete footings. This makes the posts prone to premature rot at the base. Recommend adding metal post bases.  
Railing on stairs not built to building standards (undersized). Recommend adding proper designated handrail for proper safety.  
Handrail on stairs built below minimum height standards for safety. Should be between 34"-38" at stair tread nosing. Currently only 30" high.  
Overall wood condition of railing is poor and is potentially safety hazard due to rot. Railings are noticeably loose. Recommend qualified contractor perform repairs immediately.

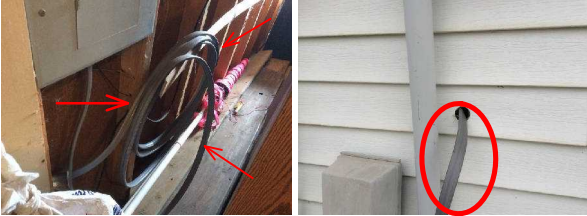
4. Conductor Type: Romex - Excess hot tub wiring not properly secured by main panel. Outdoor romex wiring not properly protected. Evaluation by a licensed electrician is recommended

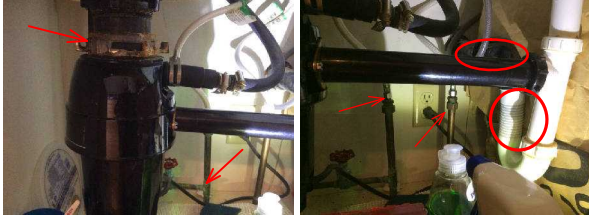
Plumbing/Fixtures: (continued)

8. 2nd Floor Kitchen Plumbing/Fixtures: PVC, ABS, Stainless steel - The faucet is leaking at base. The sink drain trap is corroded. This area should be monitored for leakage and repairs made as needed. The supply piping under the sink is corroded. It may be desirable to replace it before leaks develop. Missing shut off valves under sink, recommend installation sooner than later. Pitch on ABS drain plumbing improper, correct soon. Flexible p-trap is non-standard plumbing and should be replaced. A qualified plumber should be consulted for repairs immediately.
